Metal pollution in hydrographic networks of abandoned mining basins: The case of Linares Mining District (SE Spain)

In this field trip, we will focus on the area known as Adaro, within the Linares mining district. A review of the geology of the district and types of deposits, the mining techniques used and the concentration processes will be carried out. Based on this knowledge, the hydrogeochemical works carried out for the characterization of surface and groundwater in the studied sector are indicated, analyzing the condition they have evolved since the mining activity ended. The geophysical techniques used for the characterization of mining dams are also described and the effectiveness of the sealing carried out in some of these restored dams is evaluated.

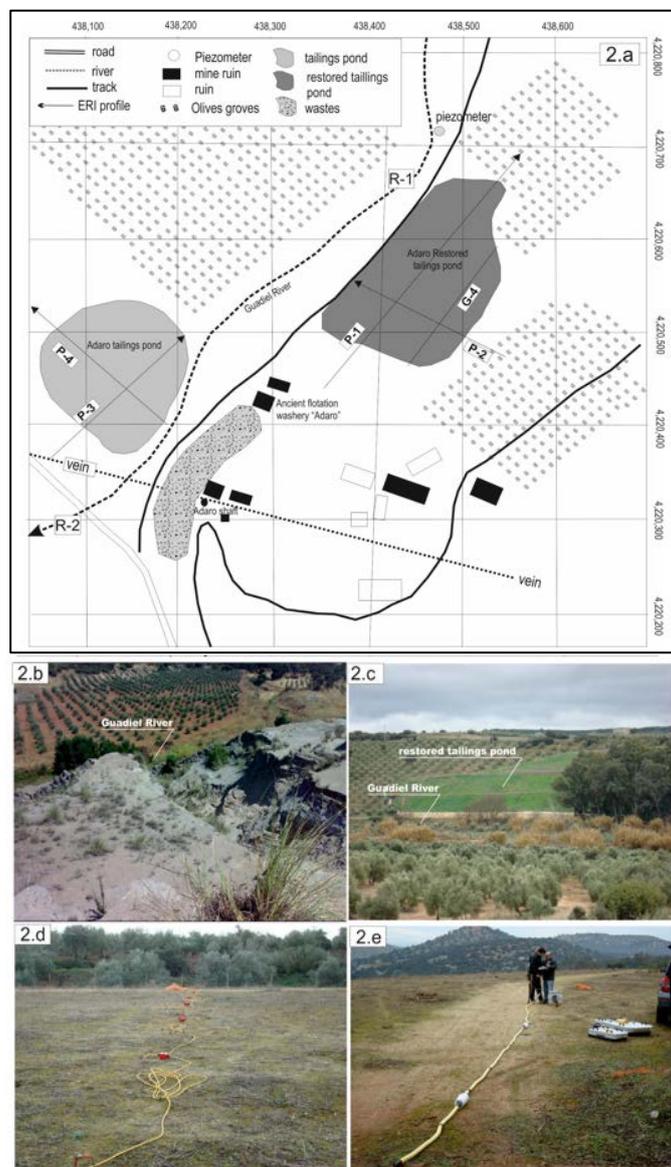
For this activity, the waste deposits of an old flotation plant (Adaro washery, Fig. 1), in the mining district of Linares, were chosen. There are two tailing ponds, one located along the left bank of the Guadiel River (restored in 2011) and another (unrestored) on the right bank (Fig. 2). The aim of this field trip is to visit these dams and showing the characterization of these waste materials and the effectiveness of the sealing techniques employed.

Fig.2. Location of the studied tailings ponds with the positions of the piezometer, ERI and GPR profiles (P.1, P.2, P.3, P.4 and G4). R-1 and R-2: surface water sampling points in the Guadiel River (2.a). Tailings pond before restoration affected by a landslide (2.b). Restored tailings pond (2.c). Electrical resistivity imaging profile 2 (2.d). Ground penetrating radar equipment used in this study: 30-MHz Rough Terrain Antennas (RTA) and 100 and 250 MHz screened antennas (2.e) (Cortada et al. 2017).

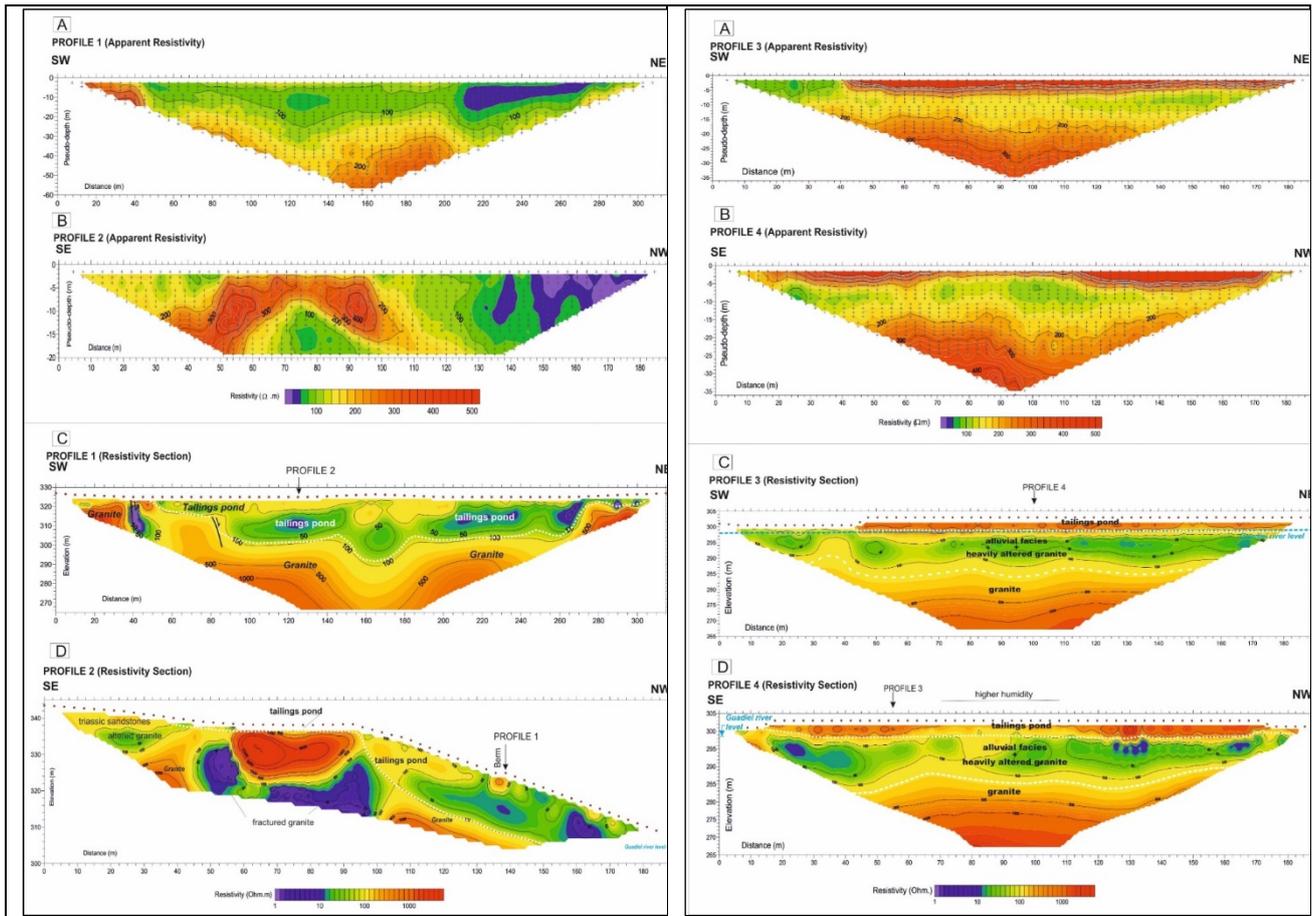
In total, 4 electrical tomography profiles have been made with 64 electrodes (Cortada et al., 2017) located in Figure 2. Two of them have been carried out in the restored pond (P-1 and P-2 in Fig. 2) with a length of 320 m each, and another two in the unrestored pond (P-3 and P-4 in Fig. 2), of 192 m per profile. The interpretations of the electrical tomography profiles have been made from the apparent resistivities obtained in the field work, treated by means of the specific resistivity and induced polarization software RES2DINV (Griffiths and Barker, 1993; Loke and Barker, 1996; Loke and Dahlin, 2002). Figure 3 shows the two profiles made on the restored dam, both with apparent resistivity values (A and B in Fig. 3) and real resistivities (C and D in Fig. 3).

The profiles have been designed to cover the entire dam, in order to characterize the residue and the contact with the substrate. Profile 1, SW-NE direction, was made in one of the berms of the dam. From the resistivity values, two large sets can be differentiated (C in Fig. 3): a superficial one, with low values (less than 150 $\Omega\cdot\text{m}$) that is associated with the sludge dam, and another set, with high values. increasing resistivity (which can exceed 2000 $\Omega\cdot\text{m}$) associated with granite. Within the granite assemblage, in the highest part, the lowest resistivity values appear, which is associated with the high degree of alteration that this rock presents on the surface. At depth, the resistivity values increase associated with a progressively healthier granite.

In the longitudinal profile of the structure (D in Fig. 3), as in the previous case, two sets could be considered: the granite and the mining deposits. A very irregular topographical base is detected, on which the sludge was deposited, filling two depressions, with changes in power in the fillings that range between 5 and 7 meters in the crest area up to 35 m in the middle part of the slope. In the fill, a surface level with somewhat higher resistivity values is observed in a discontinuous way, especially in the berm areas and in the lower part of the slope, which suggests areas in which the waterproofing has not been as effective. Bearing in mind that the granulometry variations in this dam are not very significant, ranging between silt and fine sand, the resistivity variations observed in this fill (between 30 and 150 $\Omega\cdot\text{m}$) are related to changes in humidity and not with lithological changes, as occurs in other dams in the sector (Martínez et al. 2014; 2016; 2021). On the other hand, the granitic basement is characterized by presenting high resistivities, with important and abrupt decreases in the values (up to 50 $\Omega\cdot\text{m}$) that are difficult to explain. These

could be attributed either to alteration zones associated with fractures or even to old mining operations currently filled with mud and water. Therefore, in profile 1, a higher level with a lower degree of humidity could be considered, which could be related to the restoration and waterproofing work carried out. However, this level of medium resistivity (between $100\text{--}150\ \Omega\cdot\text{m}$) is not continuous, being lost at both ends of the mining dam, in contact with the granite. From this it can be deduced that the waterproofing process was not completely achieved in the perimeter area of the pool, in contact with the substrate. For this reason, this perimeter zone continues to be a recharge zone for leachates.

Fig.3. Electrical resistivity imaging profiles (profiles 1–2). The position of each profile is shown in Fig. 2. (Cortada et al., 2017).

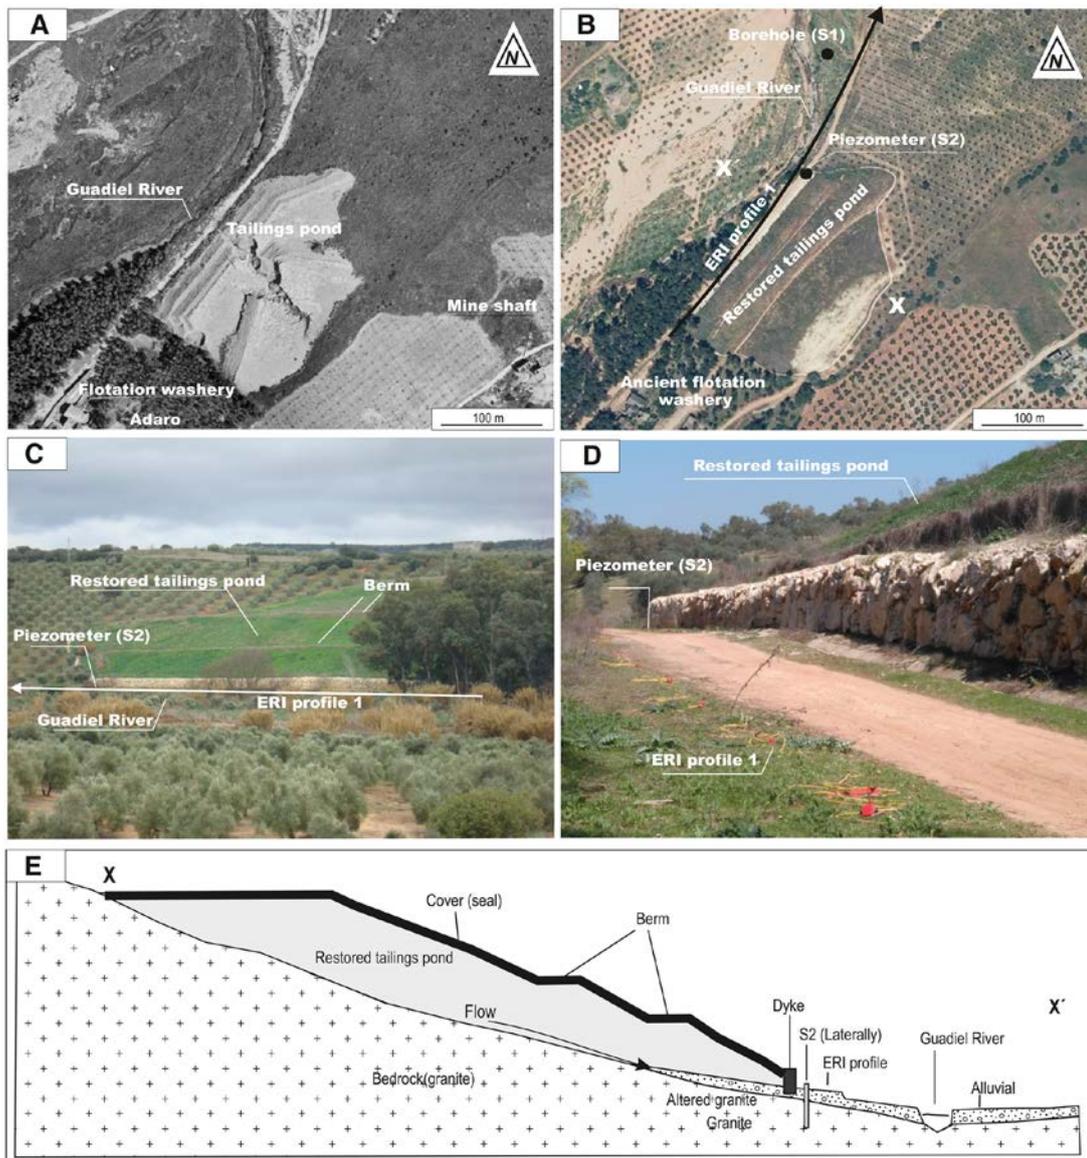
Other works carried out later, in which Electrical Resistivity and Induced Polarization have been measured, at the foot of the restored dam next to the Guadiel River (Rey et al, 2020) (Fig. 5 and 6), reveal the presence of possible leachate that would be taking place at the foot of the structure, as can be seen in figure 6D, where we assimilate the chargeability values between 5 and 8 mv/V measured superficially to these leachates.

Fig.5. Position of the Resistivity and Induced Polarization profile made at the foot of the Adaro dam. A) dam before restoring. B and C) restored dam and profile position. D) Layout of the wiring at the foot of the dam. E) cross-sectional profile of the dam and situation with respect to the Guadiel river (Rey et al, 2020).

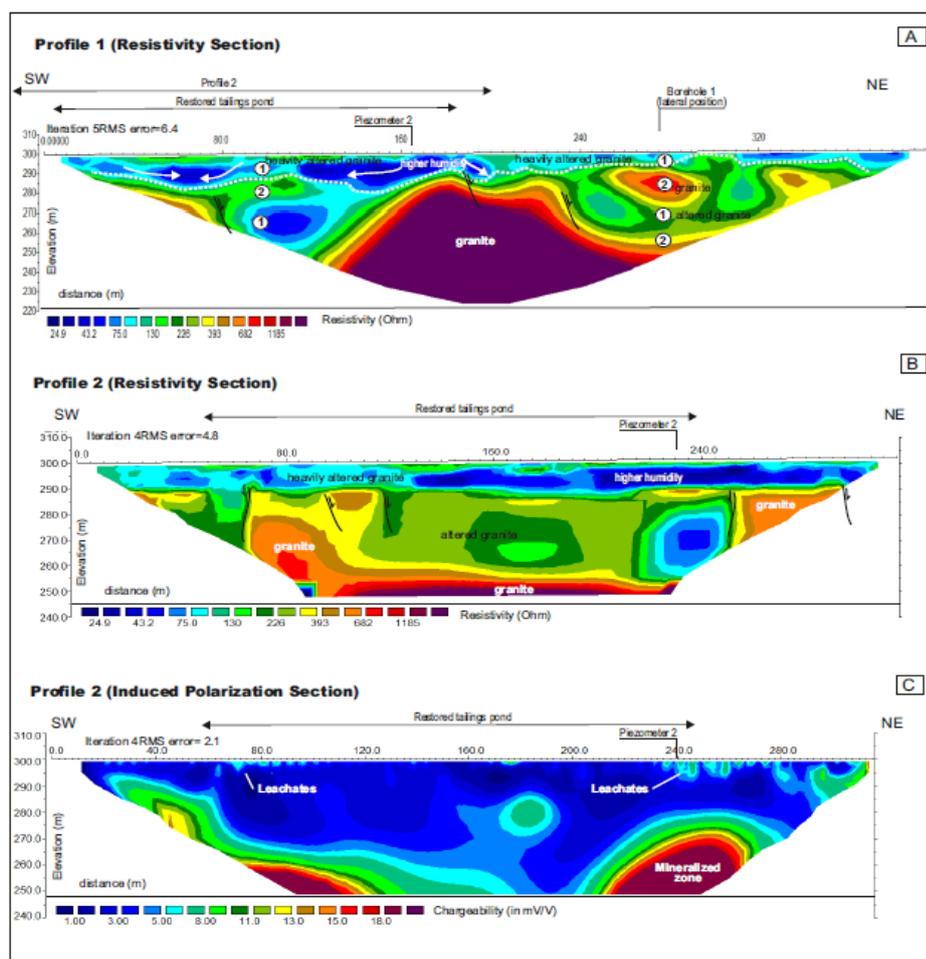
In Fig. 6, it is represented: A) real resistivity in a profile 395 meters long (80 electrodes every 5 meters). B) real resistivity of a profile 315 meters long (64 non-polarizable electrodes every 5 meters). C) Chargeability obtained in the Induced Polarization profile (315 meters).

Fig.6. A) Real resistivity of the 395 m profile. B) Real resistivity of the 315 m profile. C) Chargeability of the Induced Polarization profile (315 meters) made at the base of the Adaro dam (Rey et al, 2020).
